S U P E R F U N D U P D A T E

A R K A N S A S C O M P A N Y
1 8 5 F O U N D R Y S T R E E T
N E W A R K , N E W J E R S E Y

S E P T E M B E R 1 7 , 1 9 8 7

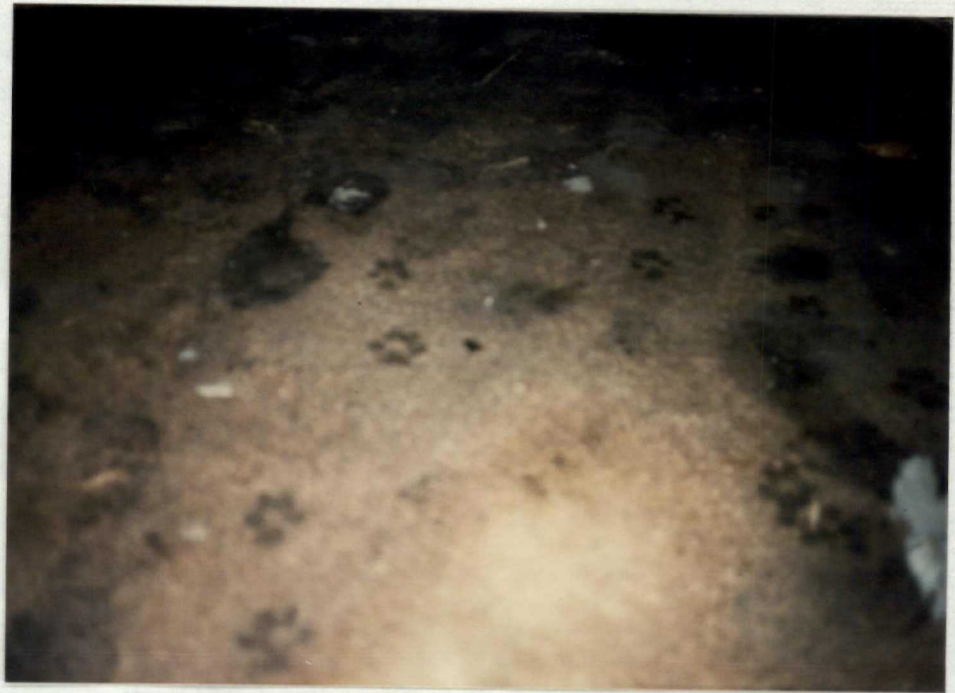
Building 28 First Floor

All four floors are grossly contaminated. Spills are prevalent throughout the building. They range from pH 2 to 11. Spills have crystallized up to a foot thick in places. Approximately 1,800 feet of asbestos-insulated piping exists in the building. A one-story, product shipping area, designated as Building 28-B is attached to the southside of the Building 28. A slimy mixture of spilled chemicals and rain water coats the floor of 28-B. About half of the drums in Building 28 are located in this room. Empty drums are stacked on their sides along the south wall. Full drums appear to be segregated by compatibility to some extent. About thirty drums of benzyl chloride, a corrosive which is intensely irritating to the skin and eyes, are stacked in two tiers in a corner of the room. Several of the drums are bulging and corroding. Since Building 28-B is already set up as a shipping room, it will be used as the staging and shipping area for hazardous wastes to be disposed.

Contaminated Floor Indicating Animal Presence

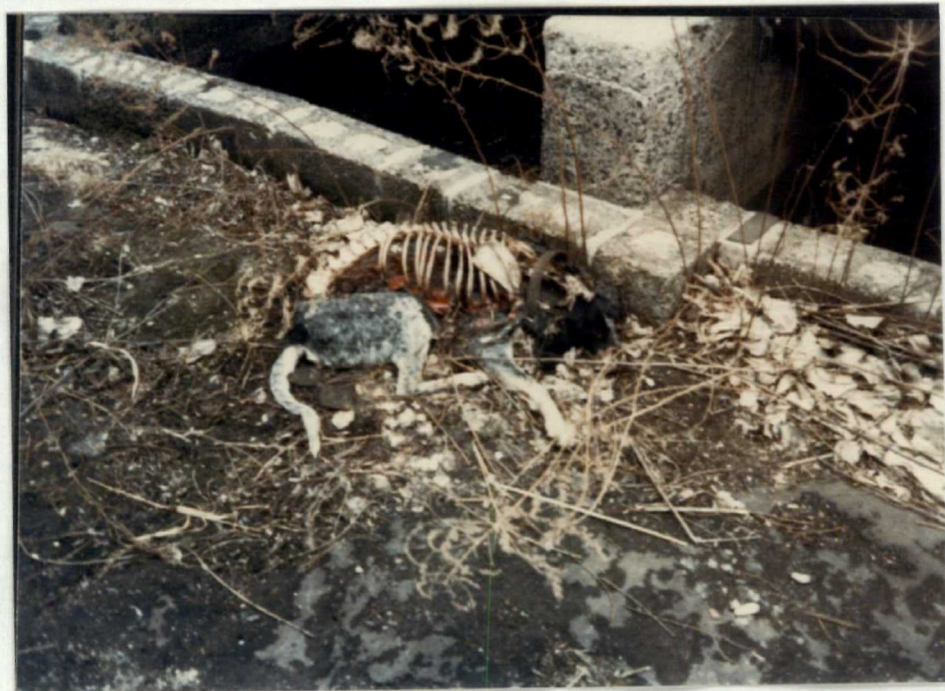
Outside Building 16 Ground Level

Possible Result of Contamination

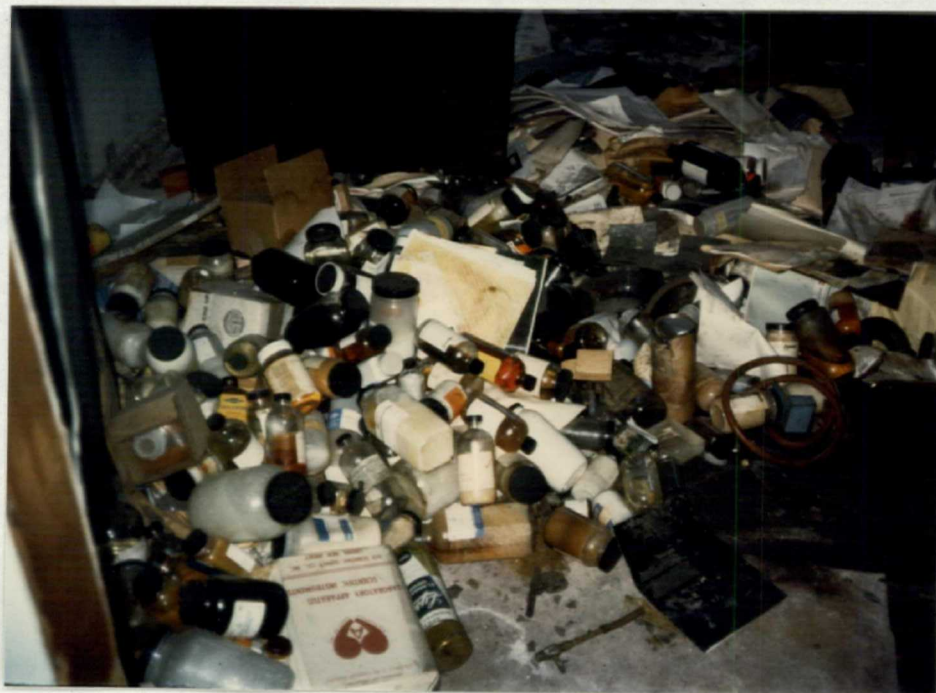
Building 30 Second Floor

Vandalized Condition of Laboratory Stock

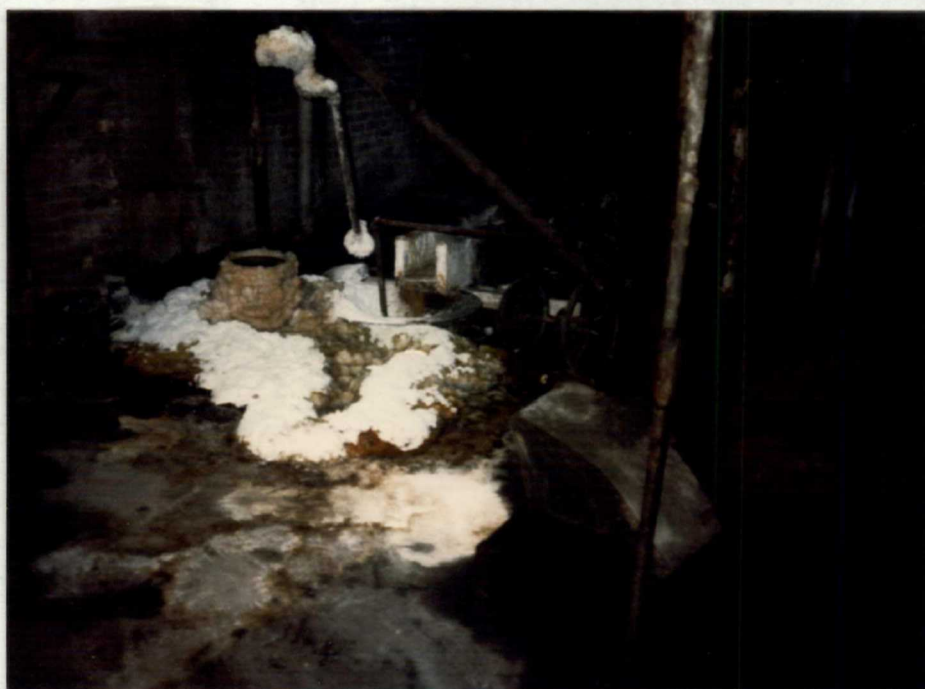
Building 28 Third Floor

Crystalline Contamination Prevalent Throughout Building

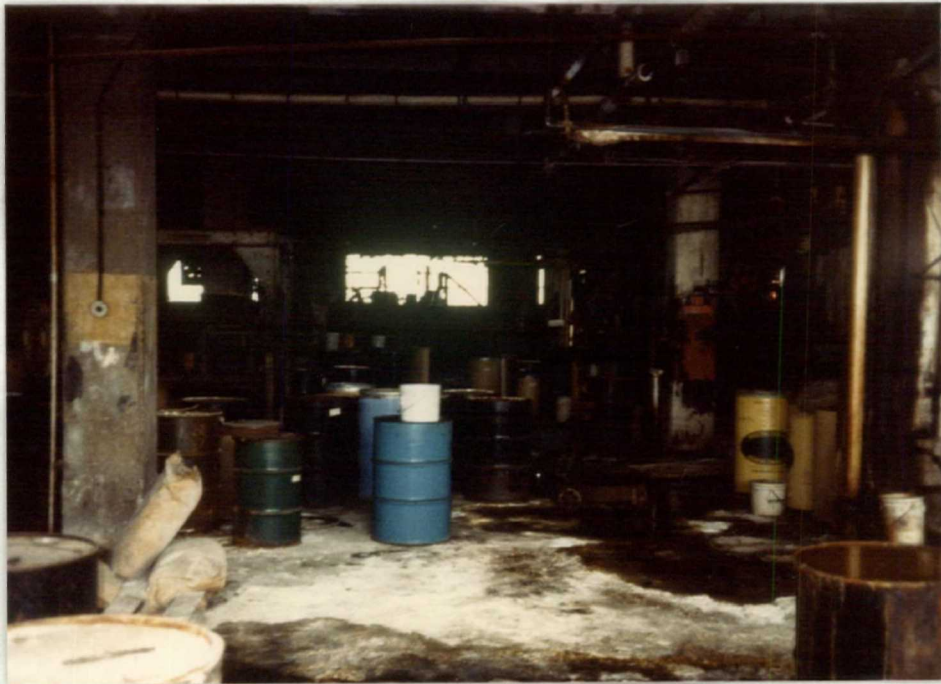
Building 28 Third Floor

Grossly Contaminated Floors Present Throughout Building

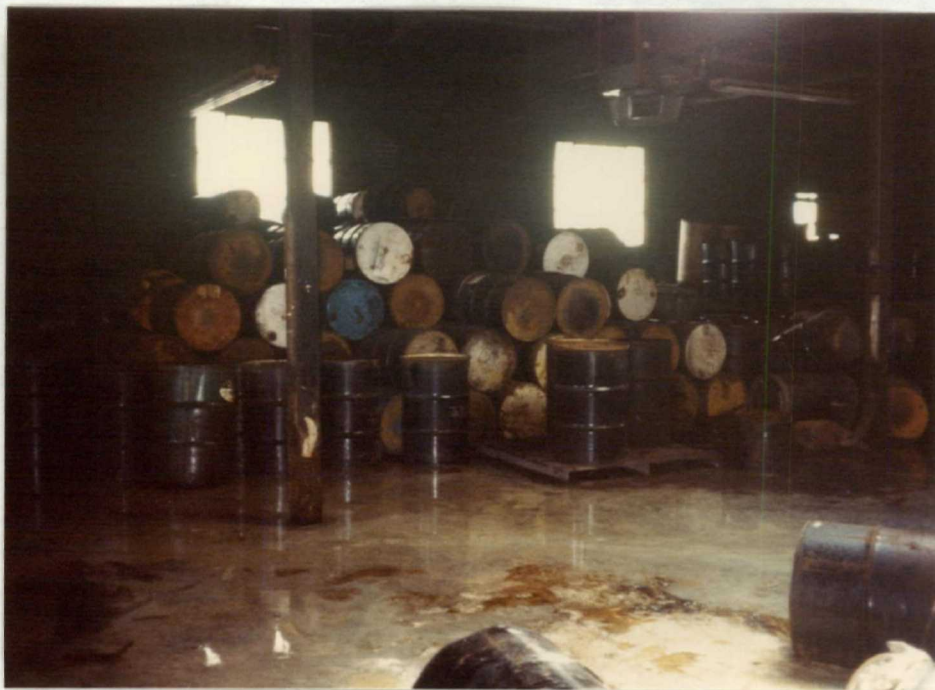
Building 28B Ground Level

Stockpiling of Full and Empty Drums Under Leaky Roof
